January 14, 2009

## User Advisory

### Universal Rescue Connection (URC) and Quick-Fill® Coupling – Unable to Connect or Leakage while Connected

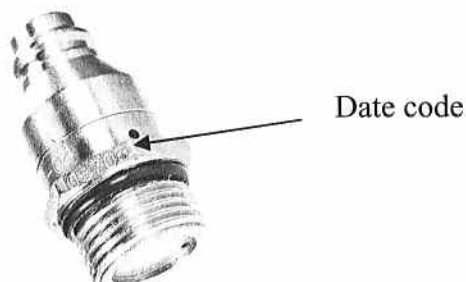
Eaton advised that they learned of eight male couplings that would not connect to the mating female coupling when both the male and female couplings were pressurized above 1000 psig. In addition to those couplings, two additional male couplings were found to leak when pressurized above 2500 psig. Eaton advised that if attempting to connect when both the male and female couplings are above 1000 psig, connection may not be possible or there may be an audible leak from the male coupling when connected. If however, the male, female, or both couplings are below 1000 psig, the connection functions properly.

Aeroquip/Eaton has identified affected male couplings as those displaying a date code within the range of "18207" through "30508". See illustration below.

**MSA is issuing this User Advisory to all purchasers of air masks equipped with a URC and/or Quick-Fill male coupling and any replacement parts containing these components that were shipped from MSA from July 2007 through December 2008. We request that users receiving this advisory inspect all URC and Quick-Fill male couplings in their possession. Remove from service all air masks with couplings displaying date codes within the above range until the coupling is tested. Units displaying date codes outside the range identified above are not affected and may remain in service.**

If any couplings are discovered with a date code within the above range, please contact your local MSA Authorized Air Mask Maintenance Center to arrange for the coupling to be tested. Only MSA certified repair persons are authorized to perform the necessary air mask coupling test. When tested, couplings that either do not connect or are found to leak will be replaced free of charge. Please note that this male coupling is a required component on all NFPA compliant air masks manufactured since 2002.
