Campaign Bulletin

Date: June 6 2016

Subject: Eaton Aeroquip LLC FD17 High Pressure Coupling Field Replacement

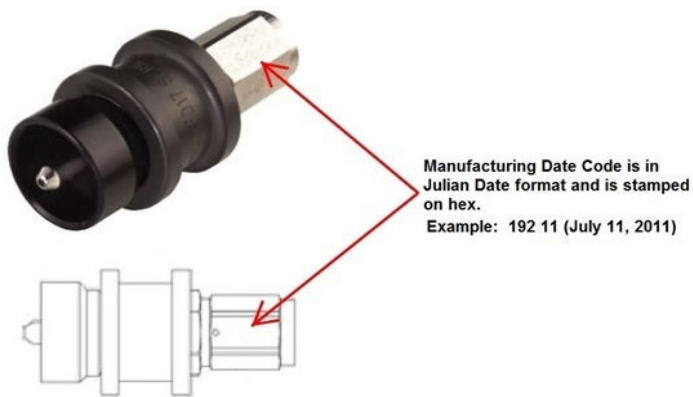
Figure One - Female Coupling

Operational Impact: Based on normal field operations, training applications and extensive testing and analysis, Eaton has determined that these inconsistencies could result in cup seal blow-out events while the couplings are being disconnected. If the FD17 coupling has the cup seal blow-out, the coupling male and female halves cannot be coupled.

March 1, 2015 through January 31, 2016 Julian Dates: 060 15 through 031 16

FD17-1003-04-04 Female Coupling

Inventory: If an Affected Product is currently in inventory or in operation in the field, and the date code is within the Affected Date Code Range, as set forth below, remove the product from inventory and field service.

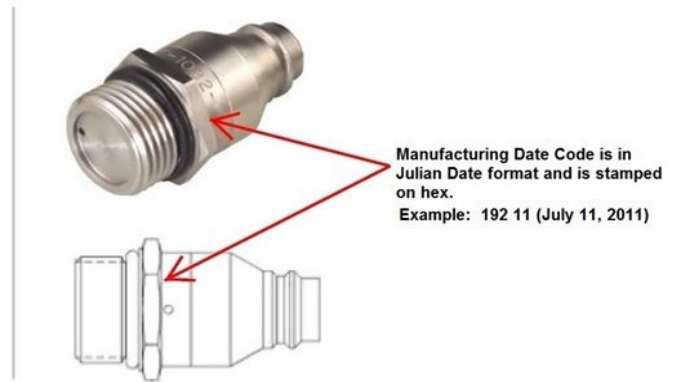
Figure Two - Male Coupling

March 1, 2015 through August 31, 2015 Julian Dates: 060 15 through 243 15

FD17-1082-10-04 Male coupling

The Julian Date Code Range on the Male FD17-1082-10-04 was increased to six digits; samples may have either five or six digits. If the coupling has six digits, please read the first five digits of the number for the Julian date code.
