Inspection Notice
MSA PFL / SRL Rivets
2.4m and 2.7m V-Edge™ Cable PFL
6m V-Edge™ Cable SRL

June 4, 2019

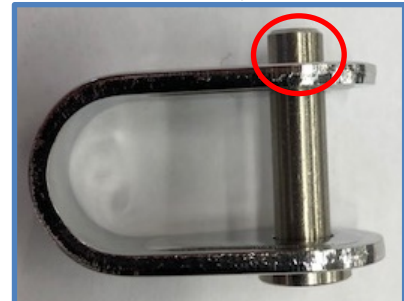
An unflared top eyelet rivet may eventually begin to dislodge from the PFL. If the rivet begins to dislodge from the PFL, the PFL may not arrest a fall.

Unflared Top Eyelet Rivet

- 1) Place the PFL on a flat surface so that there is not a load on the top eyelet rivet.
- 2) Attempt to remove the top eyelet rivet from the eyelet by pushing the rivet.
- 3) Attempt to remove the top eyelet rivet from the eyelet by pulling on the rivet.

Some small back and forth movement of the rivets is to be expected while pushing or pulling. If any of the rivets are able to be removed from the PFL/SRL, remove the PFL/SRL from service.

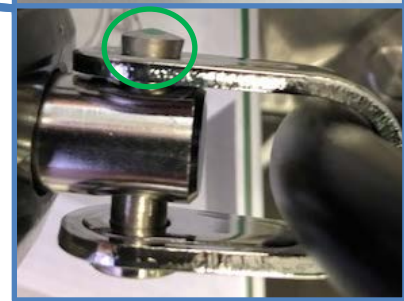
Flared Top Eyelet Rivet

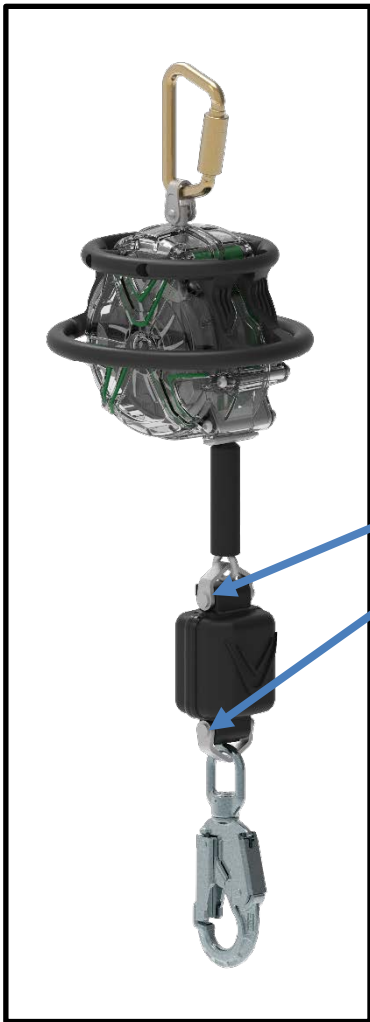
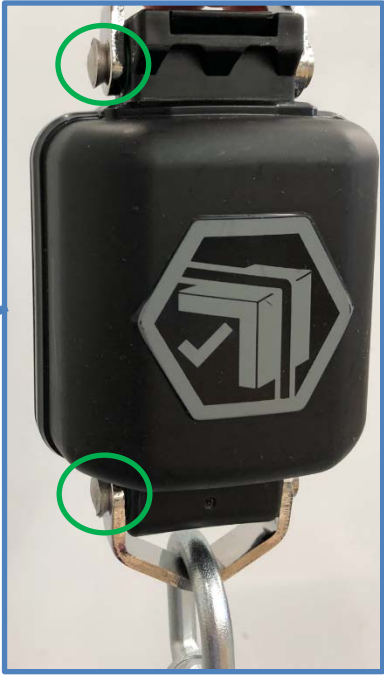
Figure B-2: 6m V-Edge Cable SRL Rivet Inspection Locations

Flared Shock Pack Rivets

- 1) Hold the SRL shock pack such that the shock pack does not make contact with a surface that would prevent movement of the shock pack rivets.
- 2) Attempt to remove the shock pack rivets by pushing the rivets.
- 3) Attempt to remove the shock pack rivets by pulling on the rivets.
