## **Safety Notice**

### **SCBA Universal Air Connection (UAC) and Quick-Fill® Hose Fittings**

### **Amended Notice**

July 14, 2016

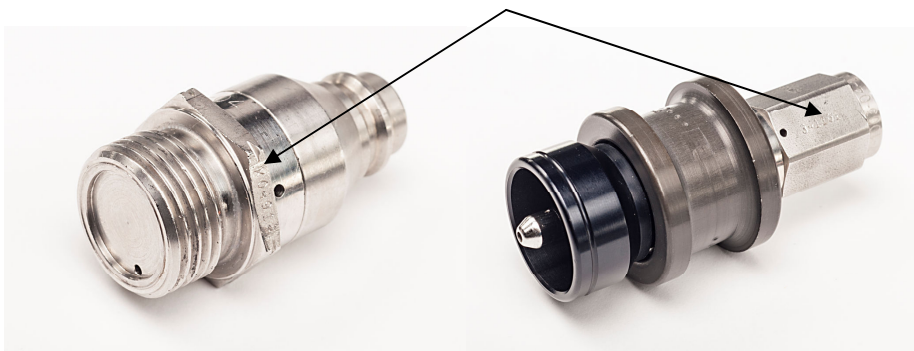
Affected fittings can be identified by Eaton's date code, which is marked on the fitting (see photos below). The first three digits of the date code are in Julian Date format for the specified year, which is indicated by the next two digits. For example, a fitting that is marked "06015" would have been manufactured on March 1, 2015. If the date code on the fitting has a sixth digit for the shift, read the first five digits.

Eaton's Date Code in Julian Date format is stamped on hex.  
Example: 060151 (March 1, 2015)

**Male Fitting**

**Female Fitting**

**MSA is replacing all male UAC and female Quick-Fill fittings within the Eaton affected date range provided below. If you have any affected fittings, follow the steps provided in the Temporary Use of Affected Fittings section below and contact your local MSA Fire Service Distributor to arrange for installation of replacement fittings as soon as possible.**
