Inspection Notice

Universal Air Connection (UAC)/ Quick-Fill® Couplers

November 30, 2018

UAC/Quick-Fill Coupler Inspection Procedure

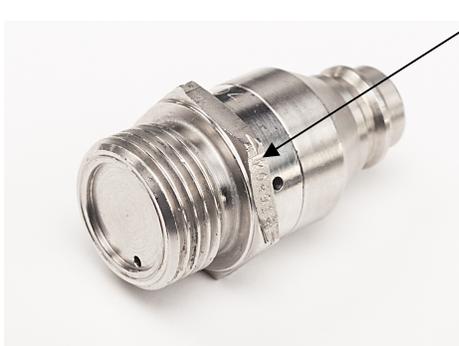
Date Code in Julian Date format is stamped on hex.
Example: 060151 (March 1, 2015)

Contact MSA Issues Resolution Group at 1-866-672-6977 to arrange for replacement of any fittings that do not pass the inspection. MSA will provide under warranty replacements for any fittings with manufacturing dates since 2007. The manufacturing date can be identified by the date code, which is marked on the fitting (see photo below). The first three digits of the date code are in Julian Date format for the specified year, which is indicated by the next two digits. For example, a fitting that is marked "06018" would have been manufactured on March 1, 2018. If the date code on the fitting has a sixth digit for the shift, read the first five digits.

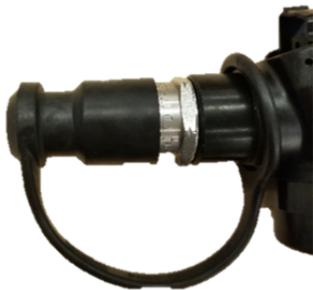
Figure 4

- a. If there is difficulty with the dust pin assembly being inserted and/or it does not fully sit into the UAC/Quick-Fill coupler as seen in Figure 4, record as a fitting needing action.

Condition	Criteria	Inspection Observation
Proper Functionality	No Air Leak	No audible leak when dust pin is pressed
Action Needed	Unable to Fully Seat Dust Pin	Visually observed in Figure 4. Expected leak if test can be performed.
	Repeatable Hissing	Continuous hissing after two test attempts with resealing of the dust pin assembly between tests.
	Significant Burst/Air Leak	Audible air leaking continuously when the dust pin is pressed.

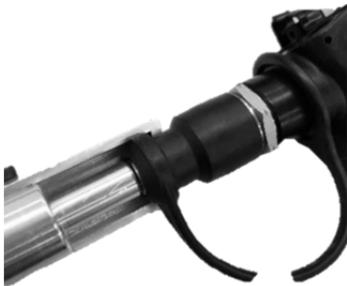
3. Using the tool (PN 10197862), align the tool as shown in Figure 5 with the lip against dust pin assembly cover.

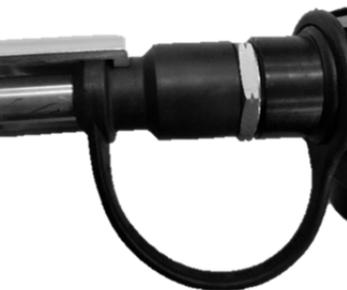
Figure 6

4. Press the tool firmly against the dust pin assembly until one can feel it depress into the coupler or the dust cover meets the hex body of the coupler, as shown in Figure 6.
