**To: Users of Air Masks Equipped with a Universal Rescue Connection Coupling**

## URC Male Coupling Tightness Inspection Procedure

## User Notice

### Universal Rescue Connection

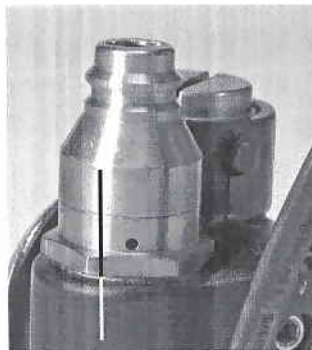
FIGURE 2  
Tight

**Tight:** If the line drawn on the coupling lines up (see Figure 2), the coupling is sufficiently tight and the air mask may be returned to service.

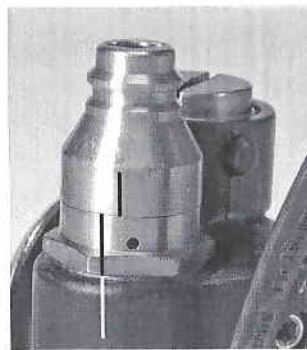
FIGURE 3  
Loose at Coupling Joint

**Loose at Coupling Joint:** If the coupling is loose or if the marked line does not line up across the coupling joint (see Figure 3), remove the air mask from service until a replacement coupling is installed.

**Note:** Only authorized MSA or Aeroquip personnel should re-tighten the coupling.

If any loose couplings are discovered, please contact your local MSA authorized air mask maintenance center. Only MSA certified repair persons are authorized to remove or install a URC coupling.
