September 11, 2009

Safety Notice

Ultima[®] XE, Ultima[®] X³, and Trigard[®] Gas Monitors

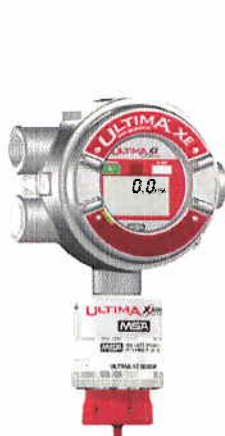
Ultima XE
Gas Monitor

This notice applies only to explosion proof sensors with stainless steel housings. General purpose sensors with plastic or stainless steel housings are not affected. The photos below depict the type of gas monitors affected.

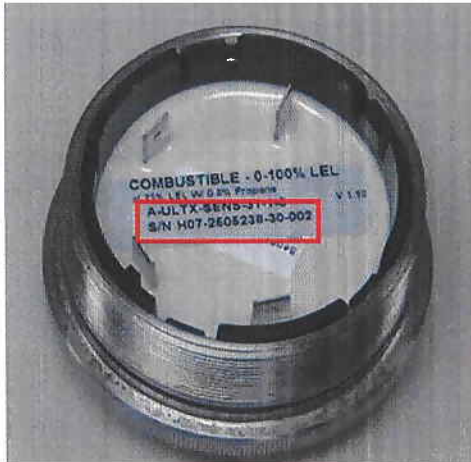
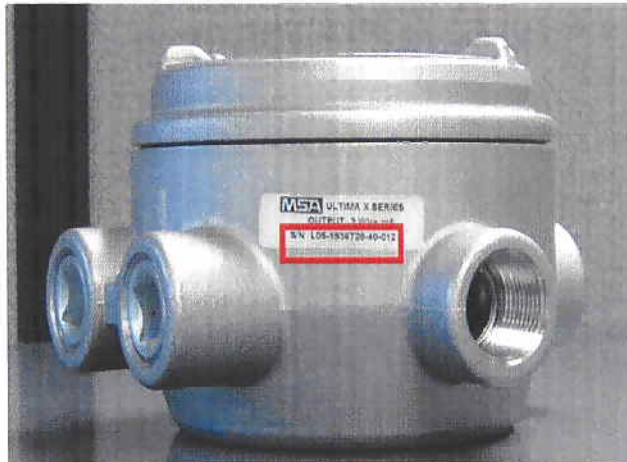
If the serial number on a sensor assembly matches any of the serial numbers on the attached alpha-numeric list, including any value for the last three digits, the sensor assembly is affected and must be replaced. The serial number is printed on the inside of the sensor assembly and on a label affixed to the monitor housing as indicated in the photos below. The serial number is also printed on the shipping box containing any unused monitor or sensor assembly.

It is important to note that if a replacement sensor assembly was installed on an existing gas monitor, the sensor assembly serial number would not be the same as the serial number identified on the monitor label. If the sensor assembly serial number is unknown, either disconnect the power from the monitor or declassify the area by using a portable gas detector, and then disconnect the sensor. Do not remove the sensor if there is any doubt as to the rating of the area.
